**DAM-BREACH FLOOD ANALYSIS
MESSERSCHMIDT AND WRIGHTS POND DAM
FALLS RIVER, WESTBROOK AND ESSEX,
CONNECTICUT**

April 1997

**US Army Corps
of Engineers**

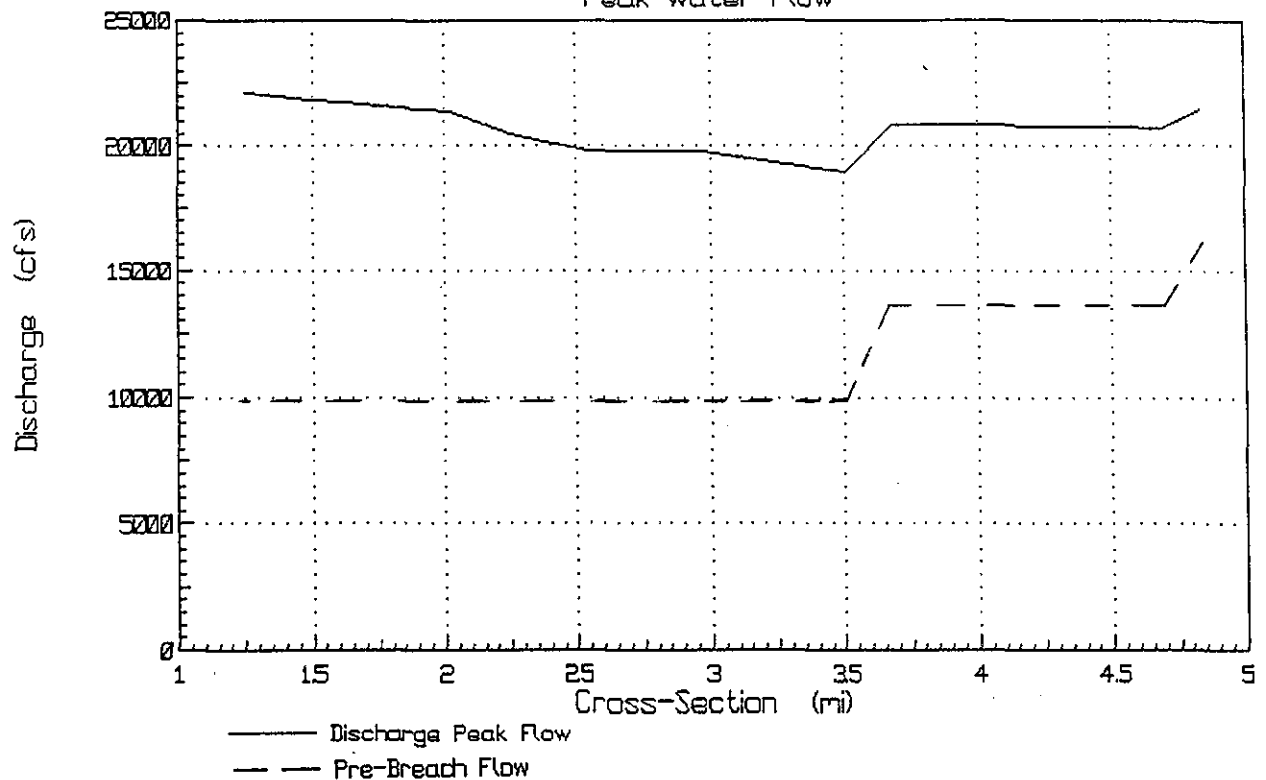
MESSERSCHMIDT FAILURE - Flood Discharge Summary Peak Water Flow
